# 基于三维激光扫描的吊索钢丝锈蚀形貌分析

**摘要:** 为研究桥梁高强钢丝锈蚀对吊索性能退化的影响, 以一座服役 14 a 的拱桥吊索为研究对象, 进行了吊索高强钢丝酸性盐雾快速锈蚀试验, 得到了 6 种不同锈蚀程度的钢丝样本。采用三维激光扫描(3D 激光扫描)技术, 研究了锈蚀钢丝表面均匀锈蚀和坑蚀的特点, 并引入点蚀系数, 分析吊索高强钢丝局部锈蚀参数的概率分布特征。研究结果表明: 钢丝平均质量损失率与时间呈幂函数关系; 经检验, 钢丝点蚀系数  $\alpha$  和  $\beta$  均服从对数正态分布; 随着锈蚀程度的加剧, 钢丝锈蚀特征趋向于均匀锈蚀特征。

## Corrosion morphology analysis of bridge suspender steel wires based on 3D laser scanning method

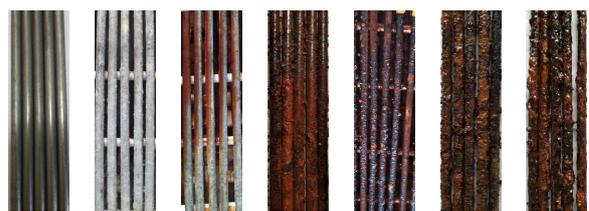
图1 不同暴露时间下钢丝锈蚀形貌

钢丝锈蚀后,外观如图1所示。在图1中,白色物质和红色物质分别为钢丝表面镀锌层和内芯基体的锈蚀产物。从图1中可以看出,盐雾暴露15 d之后,钢丝表面镀锌层已开始锈蚀,基体内芯出现了局部点蚀,随着盐雾暴露天数的增加,腐蚀向钢丝基体内芯发展,腐蚀程度愈发严重,钢丝截面呈不规则变化。

(a) 0 d (b) 15 d (c) 30 d (d) 60 d (e) 90 d (f) 120 d (g) 150 d

Fig. 1 Corrosion morphology of steel wire after different exposure time

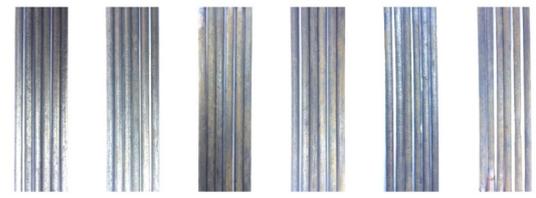
图2 除锈后钢丝样本

先将钢丝表面烘干,在室温环境下用配置好的除锈液清洗试件10 min,用软毛刷轻轻擦拭试件,除去钢丝表面膨松的锈蚀物。再用清水将试件充分冲洗,烘干,冷却至室温,再次称重并记录。锈蚀高强钢丝清洗后的外观如图2所示。在锈蚀初始阶段,仅钢丝表面镀锌层发生锈蚀,部分腐蚀严重区域出现点蚀,钢丝表面出现微小蚀坑,

钢丝截面直径未有明显变化, 随着暴露时间的增加, 钢丝表面点蚀加重, 腐蚀产物覆盖整个试件表面, 局部出现较大蚀坑, 钢丝直径明显变小。

Fig. 2 Steel wire samples after derusting

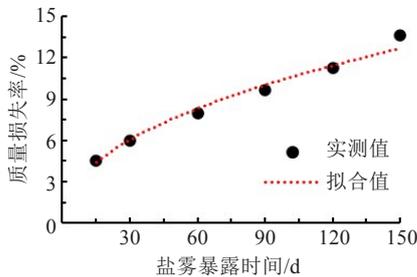
图3 平均质量损失率与盐雾暴露时间关系

钢丝平均质量损失率与盐雾环境暴露时间的变化关系如图3所示, 经回归分析得:

$$\eta_0(t) = 1.26(t - t_0)^{0.46} \quad (2)$$

式中:  $t$ 为盐雾环境暴露时间,  $d$ ;  $t_0$ 为短期酸性盐雾暴露环境下镀锌高强钢丝开始发生锈蚀所需的时间,  $d$ , 本试验  $t_0=15$ 。

从图3可以看出, 由于钢丝表面镀锌层先发生锈蚀, 锈蚀是一个从无到有的过程。因此, 初始质量损失速率较快, 待到钢丝表面覆盖的锈蚀产物形成一道保护膜后, 腐蚀速率趋缓, 随着锈蚀程度进一步加剧, 部分锈蚀产物脱落, 钢丝再次暴露在盐雾环境中, 锈蚀速率有所回升。

Fig. 3 Relationship between average mass loss rate and salt spray exposure time

1) 暴露在盐雾环境中的镀锌高强钢丝,质量损失率随锈蚀时间的变化呈近似幂函数的规律变化。

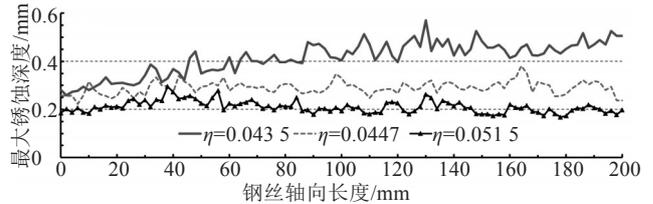
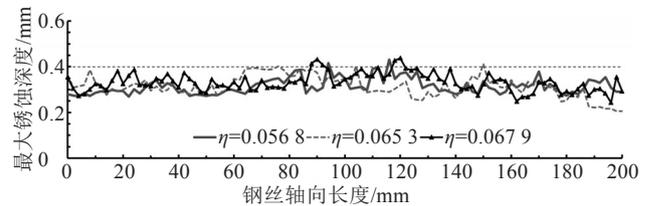
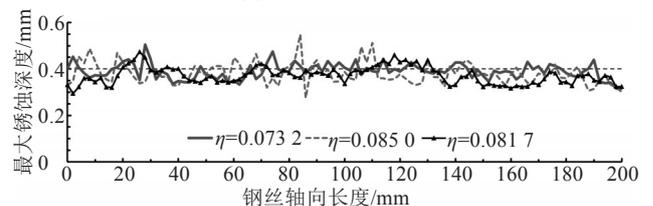
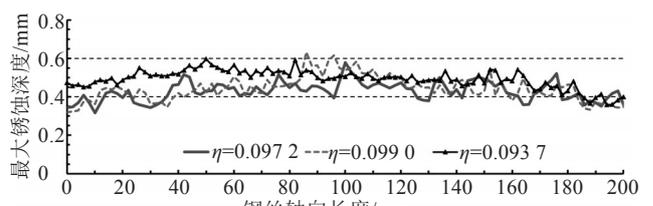
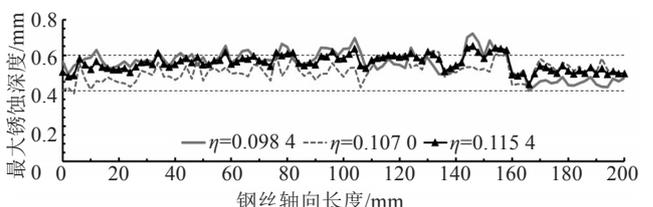
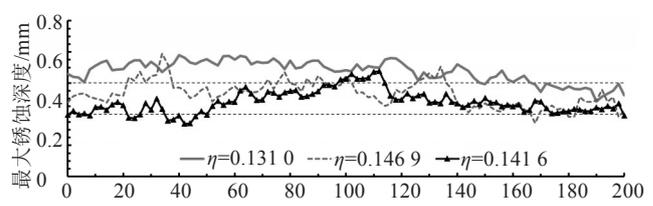
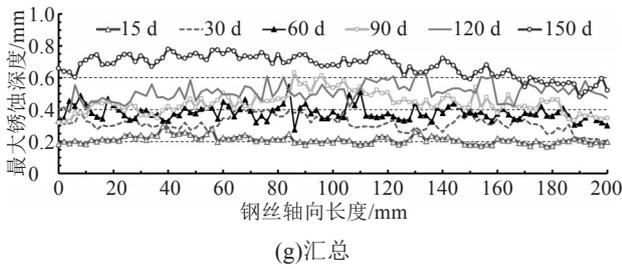
图5 不同盐雾暴露时间下最大锈蚀深度沿钢丝轴向分布  
Fig. 5 Distribution of the maximum corrosion depth along the axis of steel wire under different salt spray exposure time

不同盐雾暴露时间下, 18根钢丝表面最大点蚀深度纵向、轴向分布情况如图5所示。从图5可以看出, 最大坑蚀深度沿钢丝轴向存在较大差异, 相同盐雾暴露时间下同组钢丝最大坑蚀水平较接近。钢丝最大坑深随盐雾暴露时间的增长逐渐增大, 如图5(g)所示, 但纵坐标轴方向的波动范围逐渐变小, 表明钢丝轴向腐蚀程度趋于均匀。

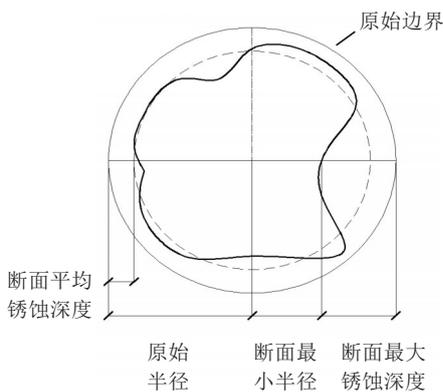
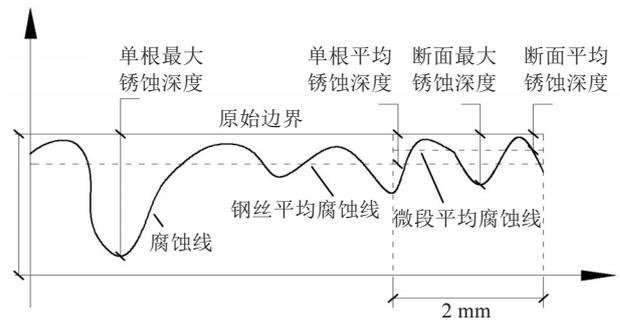
图6 锈蚀钢丝径向及轴向示意

各参数如图6所示。点蚀系数 $\alpha$ 和 $\beta$ 均不小于1。当 $\alpha$ 越大, 则钢丝轴向各截面坑深差别越大, 腐蚀程度越不均匀。同理, 当 $\beta=1$ 时, 钢丝在径向发生均匀腐蚀, 横截面直径变小, 仍近似保持圆形; 当 $\beta$ 越大, 则钢丝微段表面轮廓线越不规则。

Fig. 6 Schematic diagram of corroded steel wire in radial and axial direction

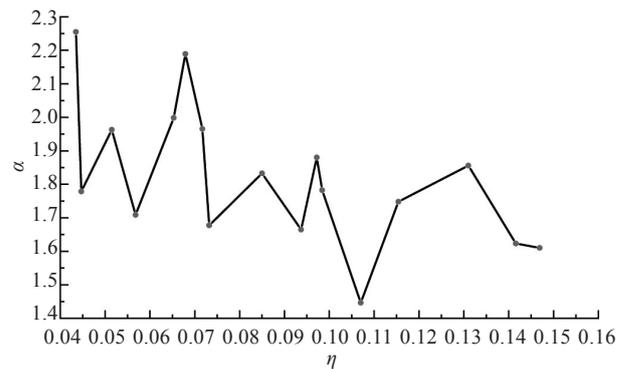
图7 点蚀系数 $\alpha$ 和质量损失率的关系

系数 $\alpha$ 随质量损失率变化曲线如图7所示。从图7可以看出, 随着钢丝质量损失率的增加, 点蚀系数 $\alpha$ 逐渐减小, 表明钢丝轴向锈蚀程度随锈蚀水平增大趋向均匀。

Fig. 7 Relationship between pitting coefficient  $\alpha$  and corrosion rate

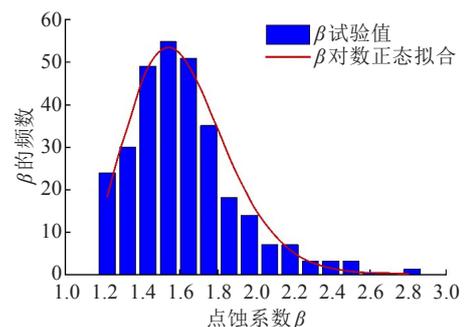
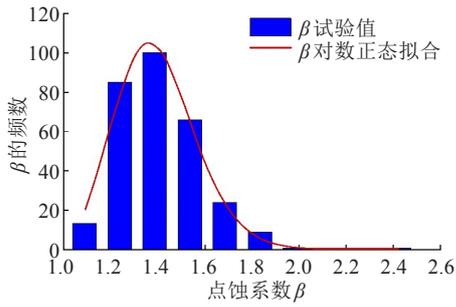
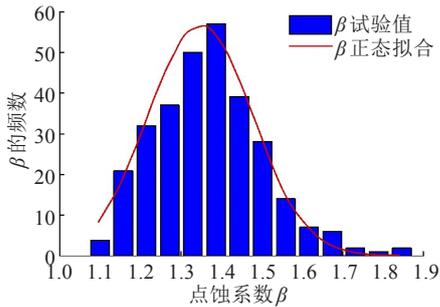
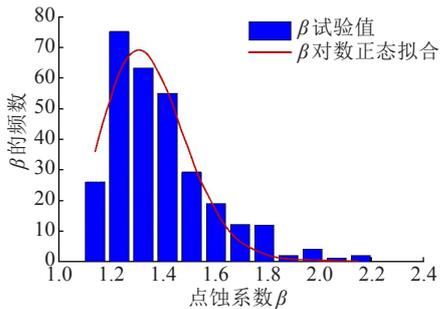
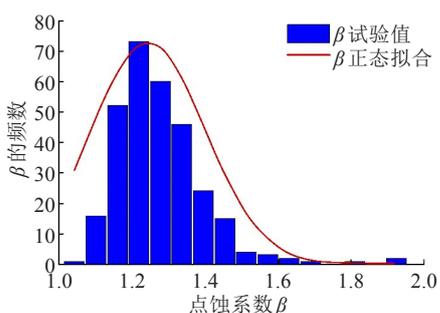
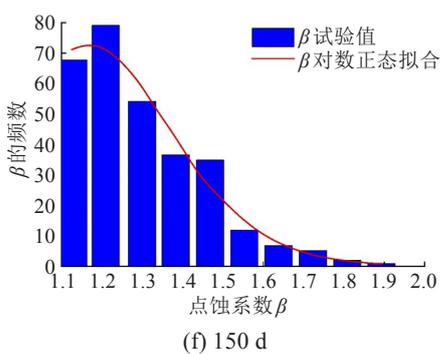
图8 参数 $\beta$ 的频率直方图和拟合曲线

不同盐雾暴露时间下钢丝试件 $\beta$ 的频率直方图如图8所示。从图8可以看出, 盐雾环境下暴露60 d和120 d的钢丝的点蚀系数服从正态分布, 其余钢丝的均服从对数正态分布。随着钢丝锈蚀程度的加大,  $\beta$ 的期望值逐渐变小。表明: 钢丝径向的腐蚀程度也趋于均匀。

Fig. 8 Frequency histogram and fitting curve of parameter  $\beta$

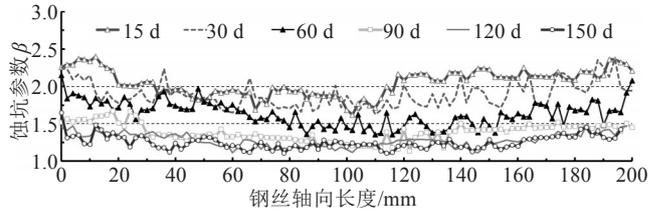
图9 不同锈蚀程度钢丝点蚀系数 $\beta$ 沿长度方向变化趋势

不同暴露时间下各钢丝 $\beta$ 值沿钢丝轴向变化曲线如图9所示。从图9可以看出，在暴露时间较短时（15~30 d）， $\beta$ 曲线相对平滑，随着暴露时间的增长（60~90 d），曲线波动范围逐渐变大，待暴露时间到达120 d时，曲线再次趋向平缓。表明：钢丝锈蚀初期，钢丝各微段的均匀锈蚀情况沿长度方向差异不明显。随着锈蚀的加剧，各微段锈蚀程度差异逐渐较大，当钢丝锈蚀到达120 d时，各微段锈蚀情况又趋于平缓。

Fig. 9 Trend of pitting coefficient  $\beta$  of steel wire with different corrosion degrees along the length direction

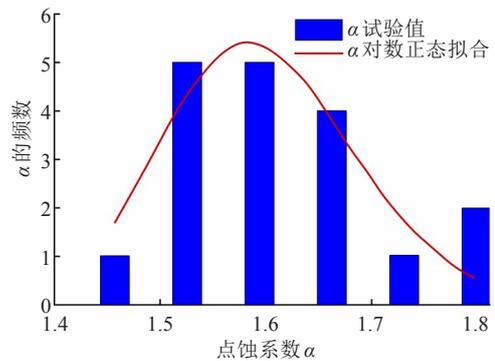
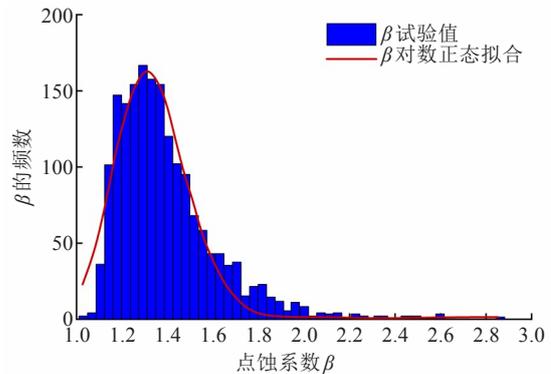
图10  $\alpha$ 和 $\beta$ 的频率直方图

统计18个 $\alpha$ 值和1800个 $\beta$ 值，得到了其频率直方图和拟合的概率密度曲线，如图10所示。从图10可以看出， $\alpha$ 值主要分布在1.5~1.7，84.7%的 $\beta$ 值集中在1.1~1.6，经检验， $\alpha$ 和 $\beta$ 均服从对数正态分布。

Fig. 10 Frequency histogram of coefficients  $\alpha$  and  $\beta$

3) 引入点蚀系数 $\alpha$ 和 $\beta$ 来表征钢丝局部腐蚀程度,统计分析了18个 $\alpha$ 值和1 800个 $\beta$ 值,结果表明:高强钢丝的点蚀系数 $\alpha$ 和 $\beta$ 服从对数正态分布。
