## 桥梁倒塌成因与抗倒塌性能提升路径综述

**摘 要:** 桥梁倒塌事故时有发生, 通常会造成严重的人员伤亡和财产损失。我国桥梁众多, 剖析导致桥梁倒塌的主要诱因, 并结合桥梁防灾技术的研究进展探究桥梁抗倒塌的技术路径具有重要意义。首先, 基于国内外桥梁倒塌案例, 对桥梁倒塌的原因进行了总结和分类, 分析表明设计缺陷、施工工艺不合理、在役期间维养不当等都有可能造成桥梁倒塌, 而船舶撞击、爆炸、火灾、地震等突发事件或自然灾害也严重威胁着桥梁安全。随后, 从上部结构破坏和下部结构破坏两个层面探究了桥梁倒塌风险的防控路径。由上部结构破坏引发的桥梁倒塌案例可知, 不同形式的桥梁在倒塌前呈现出了特有的受力特征: 梁桥的倒塌通常与超限荷载或侵蚀环境等因素引起的结构局部损伤累积有关; 拱桥的倒塌通常与结构局部损伤、拱圈的稳定性等因素有关; 悬索桥受主缆腐蚀、疲劳损伤等因素影响较大; 斜拉桥拉索断裂或锚固区损坏易导致桥梁坍塌。此外, 地基沉降、基础冲刷及撞击引起的桥梁下部结构破坏也极易造成桥梁局部或整体倒塌。最后, 结合桥梁防灾技术的研究进展, 归纳了若干提高桥梁抗倒塌能力的技术措施, 包括设置阻尼系统、采用摇摆自复位桥墩、设置限位与防落梁系统等。研究内容有助于全面认识桥梁的倒塌行为, 并为桥梁结构的抗倒塌设计提供借鉴。

## Causes of bridge collapse and approaches to improve anti-collapse performance: a review

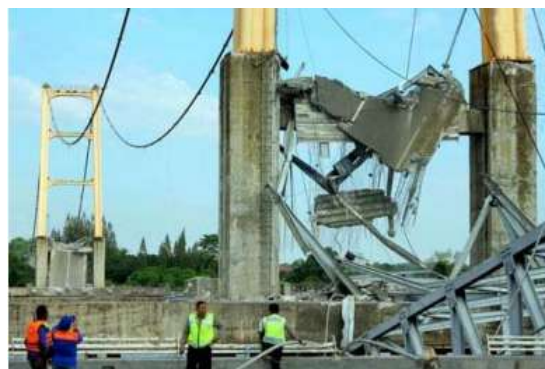
图1 Kutai-Kartanegara大桥倒塌事故<sup>[12]</sup>

Fig. 1 Collapse of the Kutai-Kartanegara Bridge<sup>[12]</sup>

Quebec大桥在施工过程中倒塌<sup>[6]</sup>,分析表明该事故主要是由桥梁主跨悬臂结构设计不合理、过高估计钢材承载能力导致的。2007年,美国35号州际公路西线密西西比河大桥在设计中缺乏必要的冗余度,运营期间也未充分预估金属疲劳的不利影响,最终导致桥梁倒塌<sup>[7]</sup>。2011年,印度尼西亚 Kutai-Kartanegara大桥在设计中未充分考虑连接部位的应力集中问题,导致支撑缆绳断裂并引发桥梁倒塌<sup>[8]</sup>,如图1所示。下部结构的设计缺陷同样可能导致桥梁的倒塌破坏<sup>[9-10]</sup>。2005年,美国利罗伊赛尔蒙桥在设计时对地基承载力考虑不足,造成桥梁结构不均匀沉降,并最终导致桥梁倒塌。2018年,由于横隔板和横梁承载力设计不足,哥伦比亚 Chirajara大桥B桥塔在施工过程中发生了结构失稳和完全倒塌<sup>[11]</sup>,如图2所示。

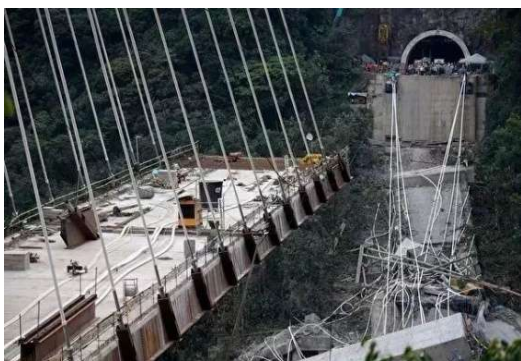
图2 Chirajara大桥倒塌事故<sup>[13]</sup>Fig. 2 Collapse of the Chirajara Bridge<sup>[13]</sup>

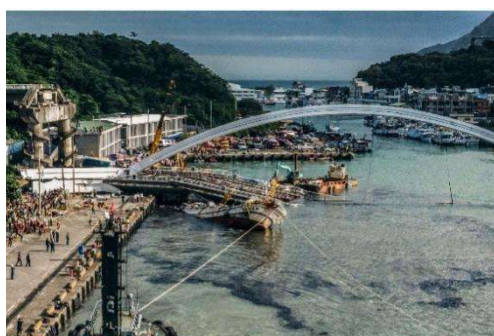
图3 南方澳跨海大桥倒塌事故<sup>[19]</sup>Fig. 3 Collapse of the Nanfang'ao Sea-Crossing Bridge<sup>[19]</sup>

2019年,台湾省宜兰县南方澳跨海大桥发生倒塌,如图3所示。事后分析表明,该桥缺失合理的养护管理,下锚头及附近吊杆被雨水锈蚀导致承载力不足,最终引起结构崩塌。此外,随着交通量的持续增长,特别是货运车辆的持续增多,桥梁因超载、超限运输而失效的风险日益增加<sup>[17-18]</sup>。2015年,由于桥面上同时行驶4辆重型货车(实际总载质量约100 t),广东省粤赣高速河源城南出口匝道桥失稳倒塌,如图4所示。2019年,无锡市312国道锡港路上跨桥侧翻,事故发生时2辆重型平板半挂车严重超载且间距较近,超载荷载过于集中所产生的偏心效应导致梁体与墩柱之间发生滑动和转动,最终引发支座失效、梁体侧向滑移和倾覆。由此可见,管理和养护不善将显著提升桥梁工程的倒塌风险。

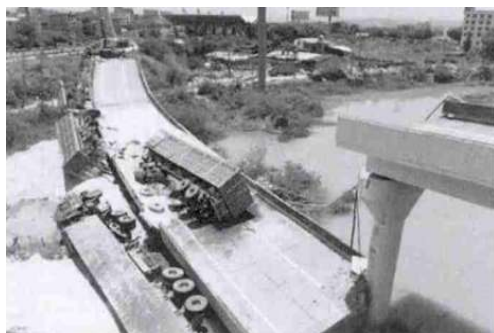
图4 粤赣高速河源城南出口匝道桥倒塌事故<sup>[20]</sup>Fig. 4 Collapse of ramp bridge at south exit of Heyuan City on Yuegan Expressway<sup>[20]</sup>

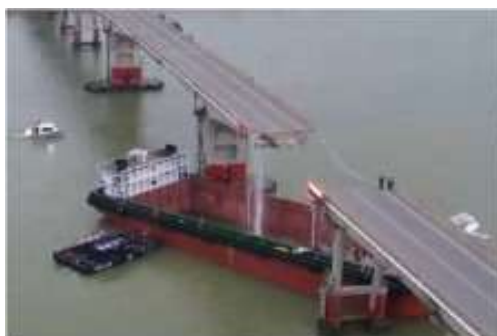
图5 沥心沙大桥倒塌事故<sup>[27]</sup>Fig. 5 Collapse of Lixinsha Bridge<sup>[27]</sup>

船舶撞击等突发事件同样严重威胁着桥梁的安全。桥墩和支座是桥梁承载荷载的关键结构,一旦遭遇车辆或船舶撞击,这些支撑构件可能失效或被破坏,进而导致桥梁丧失承载能力而倒塌<sup>[21-22]</sup>。2024年,一艘集装箱船撞击广东省沥心沙大桥桥墩,导致桥墩被破坏并引发桥面坍塌,造成人员伤亡和经济损失<sup>[23]</sup>,如图5所示;同年,建成于1977年的美国 Francis Scott Key 大桥桥墩在遭受船舶撞击后桥面垮塌,导致多人落水,并造成施工人员伤亡<sup>[24]</sup>,如图6所示。此外,船舶撞击还可能产生偏心荷载、桥梁关键部位变形或局部失稳,最终造成整体结构失效<sup>[25]</sup>。1980年,在美国佛罗里达州阳光高架桥事故中,货船撞击桥梁后产生了巨大的冲击力,导致桥面断裂并垮塌<sup>[26]</sup>;2001年,在美国得克萨斯州伊莎贝拉皇后大桥撞击事故中,拖船所拖带的驳船在失控后撞击桥体导致桥拱塌陷,从而引发桥梁大范围垮塌。上述一系列由船舶撞击导致的倒塌事故凸显了对桥梁主要承重结构进行防撞设计的必要性。

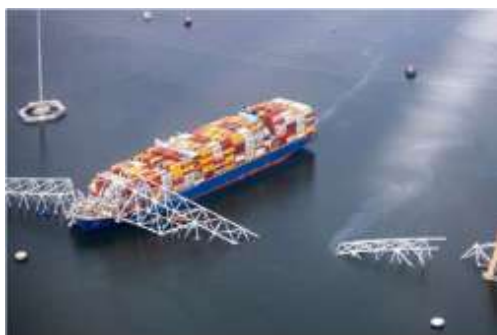
图6 Francis Scott Key 大桥倒塌事故<sup>[27]</sup>Fig. 6 Collapse of Francis Scott Key Bridge<sup>[27]</sup>

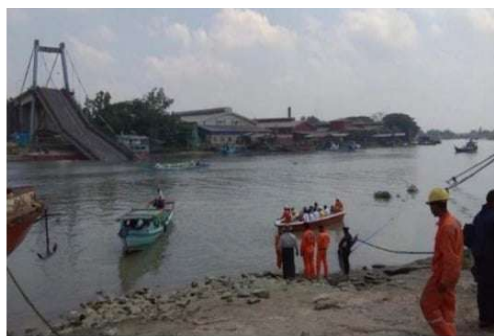
图8 Myaung Mya 大桥倒塌事故<sup>[45]</sup>

Fig. 8 Collapse of Myaung Mya Bridge<sup>[45]</sup>

3) 悬索桥。悬索桥的倒塌通常与主缆的腐蚀、疲劳损伤、拉索失衡、风荷载等因素有关。悬索桥的核心承载部分是主缆,故其承载能力的下降将直接影响桥梁的整体安全。2018年,缅甸 Myaung Mya 大桥因主缆与吊索的严重腐蚀等问题垮塌<sup>[45]</sup>,如图8所示。2022年,印度默丘河悬索桥在长期运营过程中,由于维护管理不善,主缆内部钢丝锈蚀严重,且在更换桥面铝板时未充分考虑主缆的承载能力导致部分钢丝断裂,桥面在自质量及剩余活载的作用下迅速失稳垮塌。

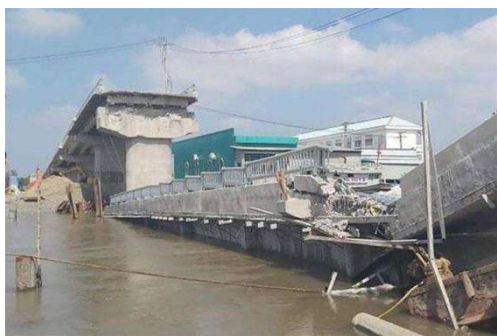
图9 越南某大桥倒塌事故<sup>[49]</sup>

Fig. 9 Collapse of a bridge in Vietnam<sup>[49]</sup>

桥梁坍塌<sup>[48]</sup>。2021年,江苏省丹阳市老黄埭桥受水流冲刷,其基础周围土层流失,基础埋置深度减小并失去侧向支撑,桥墩失稳最终桥体断裂。2021年,越南金瓯省横跨 Cai Doi Vam 河的某桥梁的桥墩逐渐下沉、倾斜并出现裂缝,最终基础与桥墩分离,桥梁倒塌<sup>[49]</sup>,如图9所示。可见,控制地基沉降并减小水流对基础的冲刷有助于降低桥梁倒塌风险。

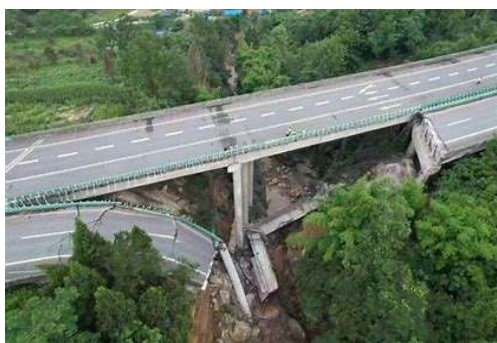
图10 恩广高速达万段6号大桥倒塌事故<sup>[52]</sup>

Fig. 10 Collapse of Bridge No. 6 on Dawan section of Enguang Expressway<sup>[52]</sup>

船舶撞击极易导致桥梁下部结构失效,主要发生在船舶航行密集的水域或受漂流物影响的区域。1975年,坦克尔号油轮撞击美国佛罗里达阳光大桥,严重破坏了桥墩结构,引发桥梁坍塌,导致严重损失<sup>[26]</sup>。1980年,一艘船舶偏离航线并高速撞向瑞典阿罗姆拱桥端部<sup>[50]</sup>,撞击产生的巨大惯性超出桥梁端部结构的设计承载能力,导致拱桥端部关键结构变形,桥梁关键部位失稳,桥面坍塌。2007年,广东省九江大桥遭受运砂船碰撞,桥墩被破坏并引发部分桥体垮塌<sup>[51]</sup>。此外,桥梁基础也可能因山坡落石的冲击而被破坏。2023年,恩广高速达万段6号大桥桥墩遭落石撞击而损毁,导致部分桥面坍塌<sup>[52]</sup>,如图10所示。上述事故凸显了结合大型航运环境对桥梁设置多层防护系统(如防撞墩、水上护栏)的必要性。
